THESIS

ANALYSIS OF UNDERBEAD CRACKING IN UNDERWATER WET WELDMENTS ON A516 GRADE 70 STEEL

Ryan D. Manning

September 1998

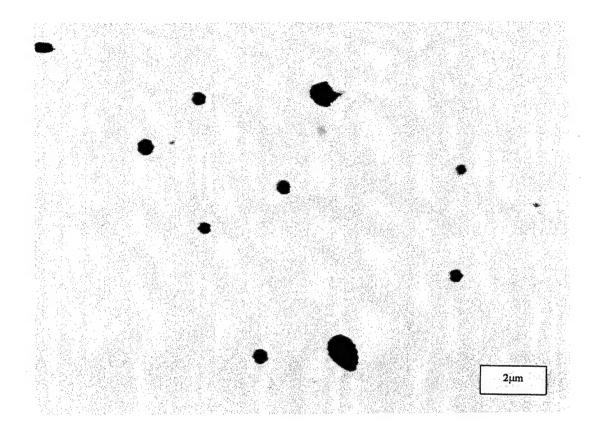
Figure 3.1 SEM micrograph of typical inclusion field in UWW05

The mean size, standard deviation and volume fraction was determined for the inclusions present in each of the fifty fields analyzed in each sample. The typical inclusion field shown in Figure 3.1 would by analyzed by counting, sizing, and identifying each inclusion through the use of the EDX. The results were then tabulated in a spreadsheet for calculation of mean size and number, standard deviation, and confidence. This data is shown in Tables 4.1 - 4.3.

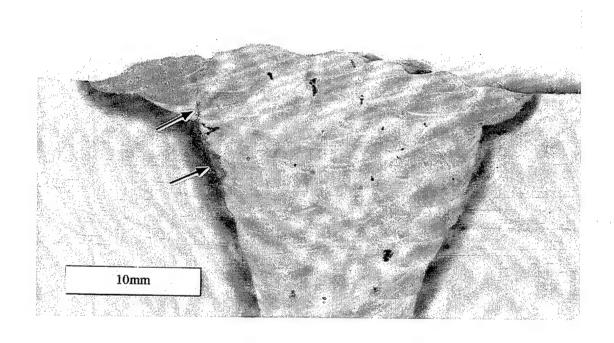
Figure 3.2 Macrophotograph of UWW05 weld sample – Underbead cracks are indicated by arrows

The macroscopic photographs taken by GRM Photo, Inc. that appear as Figures 3.2 -3.4 show various features of the weld samples. At this magnification extensive cracking from the weld cap to the root is seen on the UWW05 sample whereas the cracks in the UWW12 and UWW25 are somewhat localized near the cap of the last weld pass and are much finer. The additional feature that can be seen because of the deep etching is the effects of the multipass weld as described by Lundin, et al., [Ref. 3] and seen in Figure 2.4. Bead tempering is evident in all of the passes except the last one. This suggests a reason why the cracks are likely to originate near the last weld pass because this area of the weld sample has the highest hardness which was confirmed by microhardness measurements

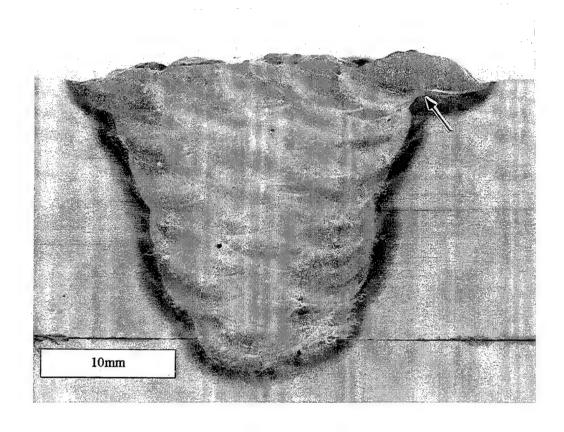
Figure 3.3 Macrophotograph of UWW12 weld sample - Underbead cracking is indicated by an arrow

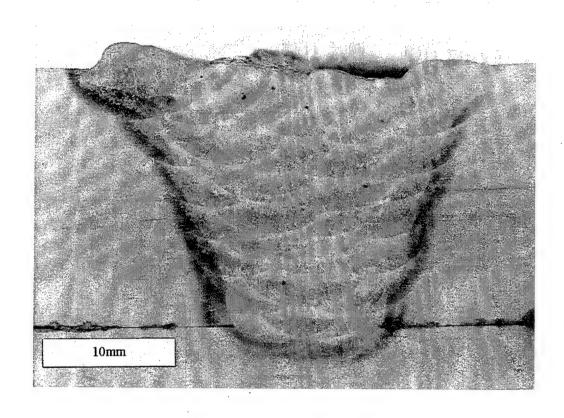
Figure 3.4 Macrophotograph of UWW25 weld sample – Underbead cracks cannot be seen at this magnification

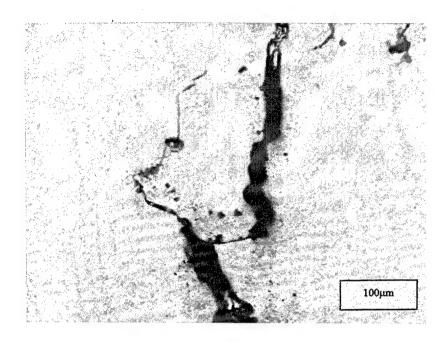
microstructure in which the cracks were found. The cracks nearly always were found in the coarse grain region of the HAZ near the fusion line. The cracks would eventually be arrested after branching into the base metal or into the fine grain region of the HAZ. The extensive crack branching found in UWW05 is shown in the micrographs in Figures 4.5 and 4.6. Note the microstructure in this region is essentially martensite and bainite. In addition, the microstructure of the weld metal was also analyzed to confirm the findings of Fox et al and Murray et al [Ref. 8, 9]. The weld metal microstructure was found to consist mostly of acicular ferrite with smaller amounts of Widmanstatten (side plate) ferrite, grain boundary ferrite, martensite and bainite.

Figure 4.5 Optical micrograph of UWW05 showing extensive crack branching

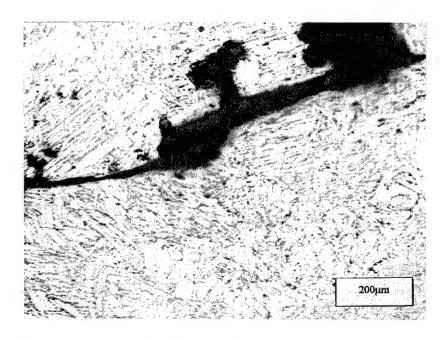
Figure 4.6 Optical micrograph of UWW05 showing martensite microstructure surrounding crack

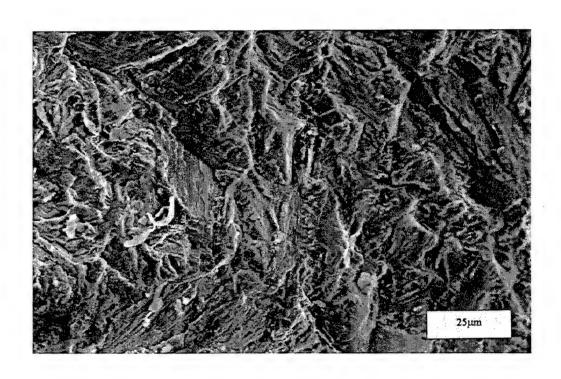
Underbead crack surfaces of UWW05 were examined in the S200 SEM to determine the mechanism of failure. Transgranular cracking and secondary cracking perpendicular to the fracture surface were clearly seen in this sample. Figure 4.7 is a micrograph which clearly shows these features which are typical of hydrogen assisted cracking.

Figure 4.7 SEM micrograph of transgranular cracking on the surface of the fracture with secondary cracking
